# City of Tarpon Springs, Florida

Heritage Preservation Board

## REGULAR SESSION AGENDA AGENDA

MONDAY, MAY 6, 2024

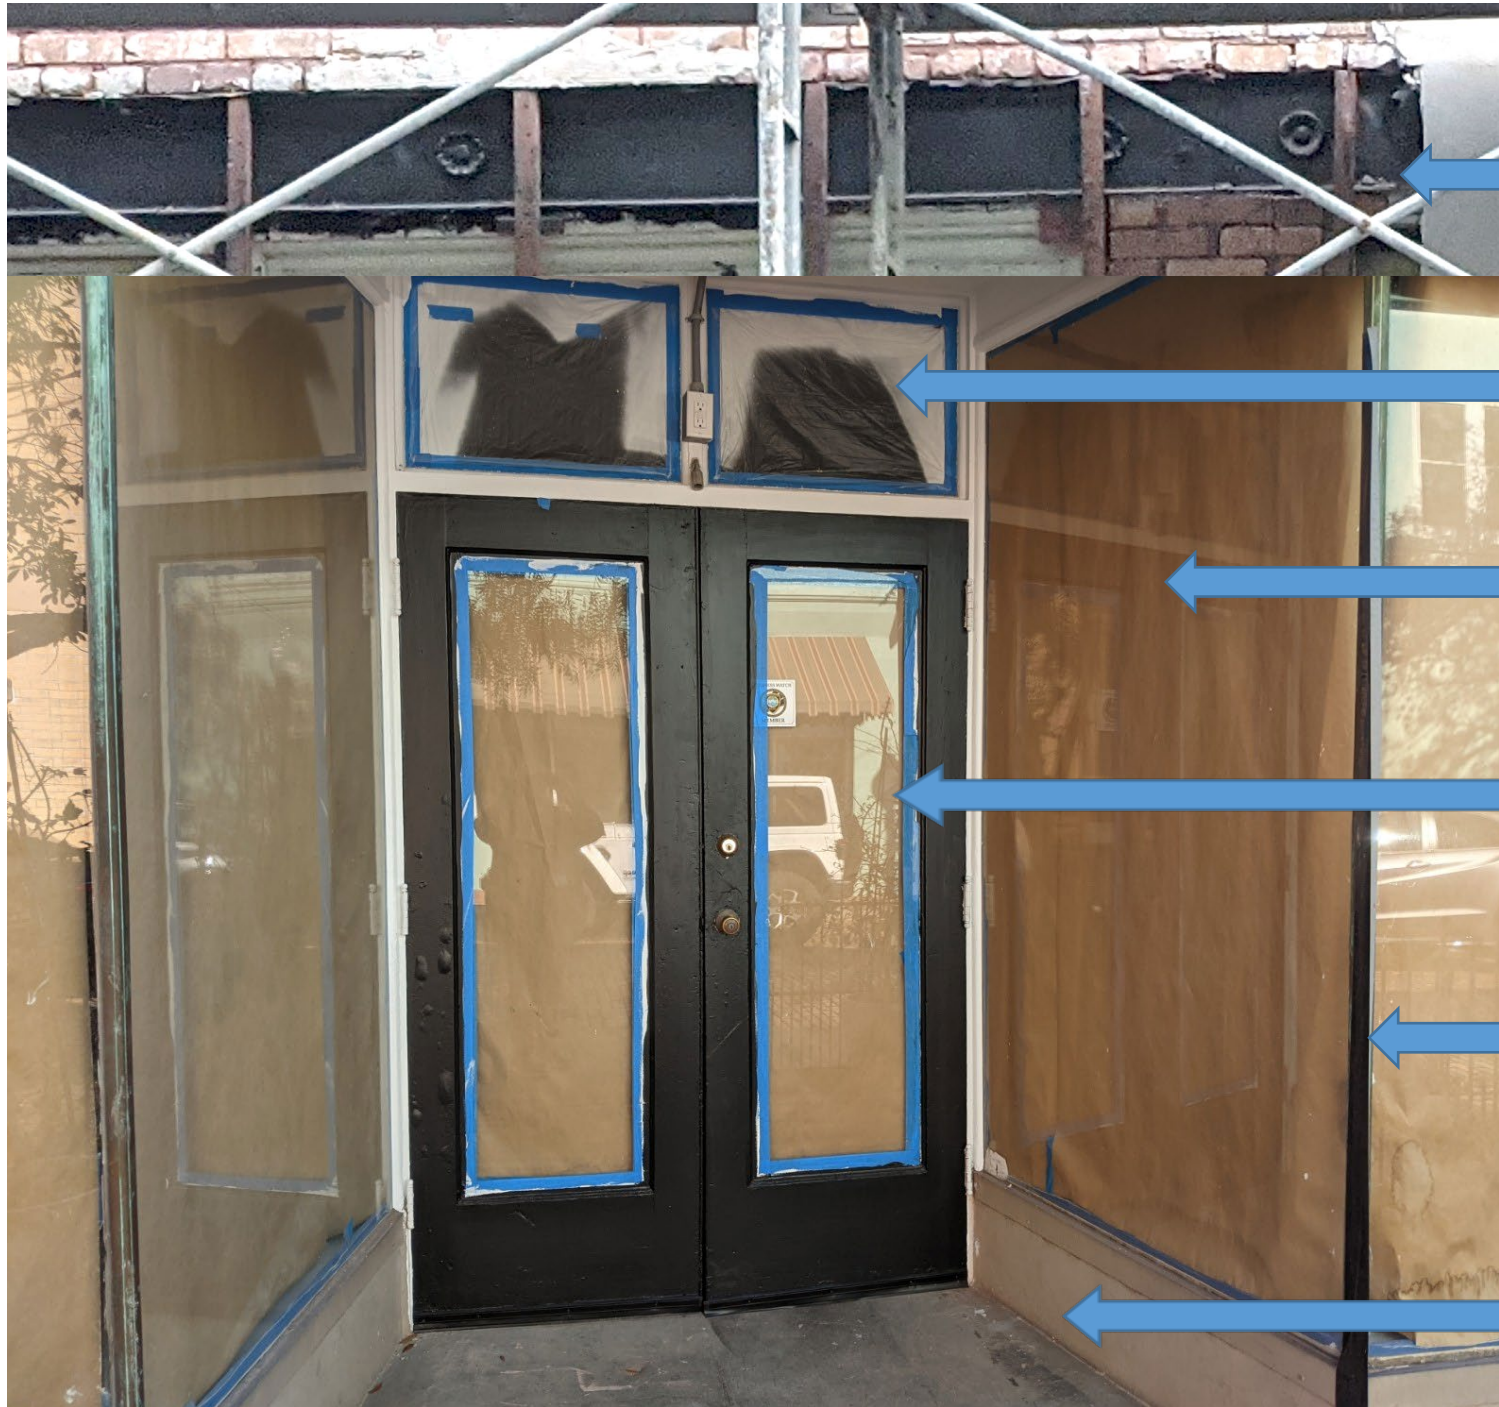
**STOREFRONT CORNICE**

**TRANSOM**

Recessed Entry Reduced

New/Widened  
Mullions

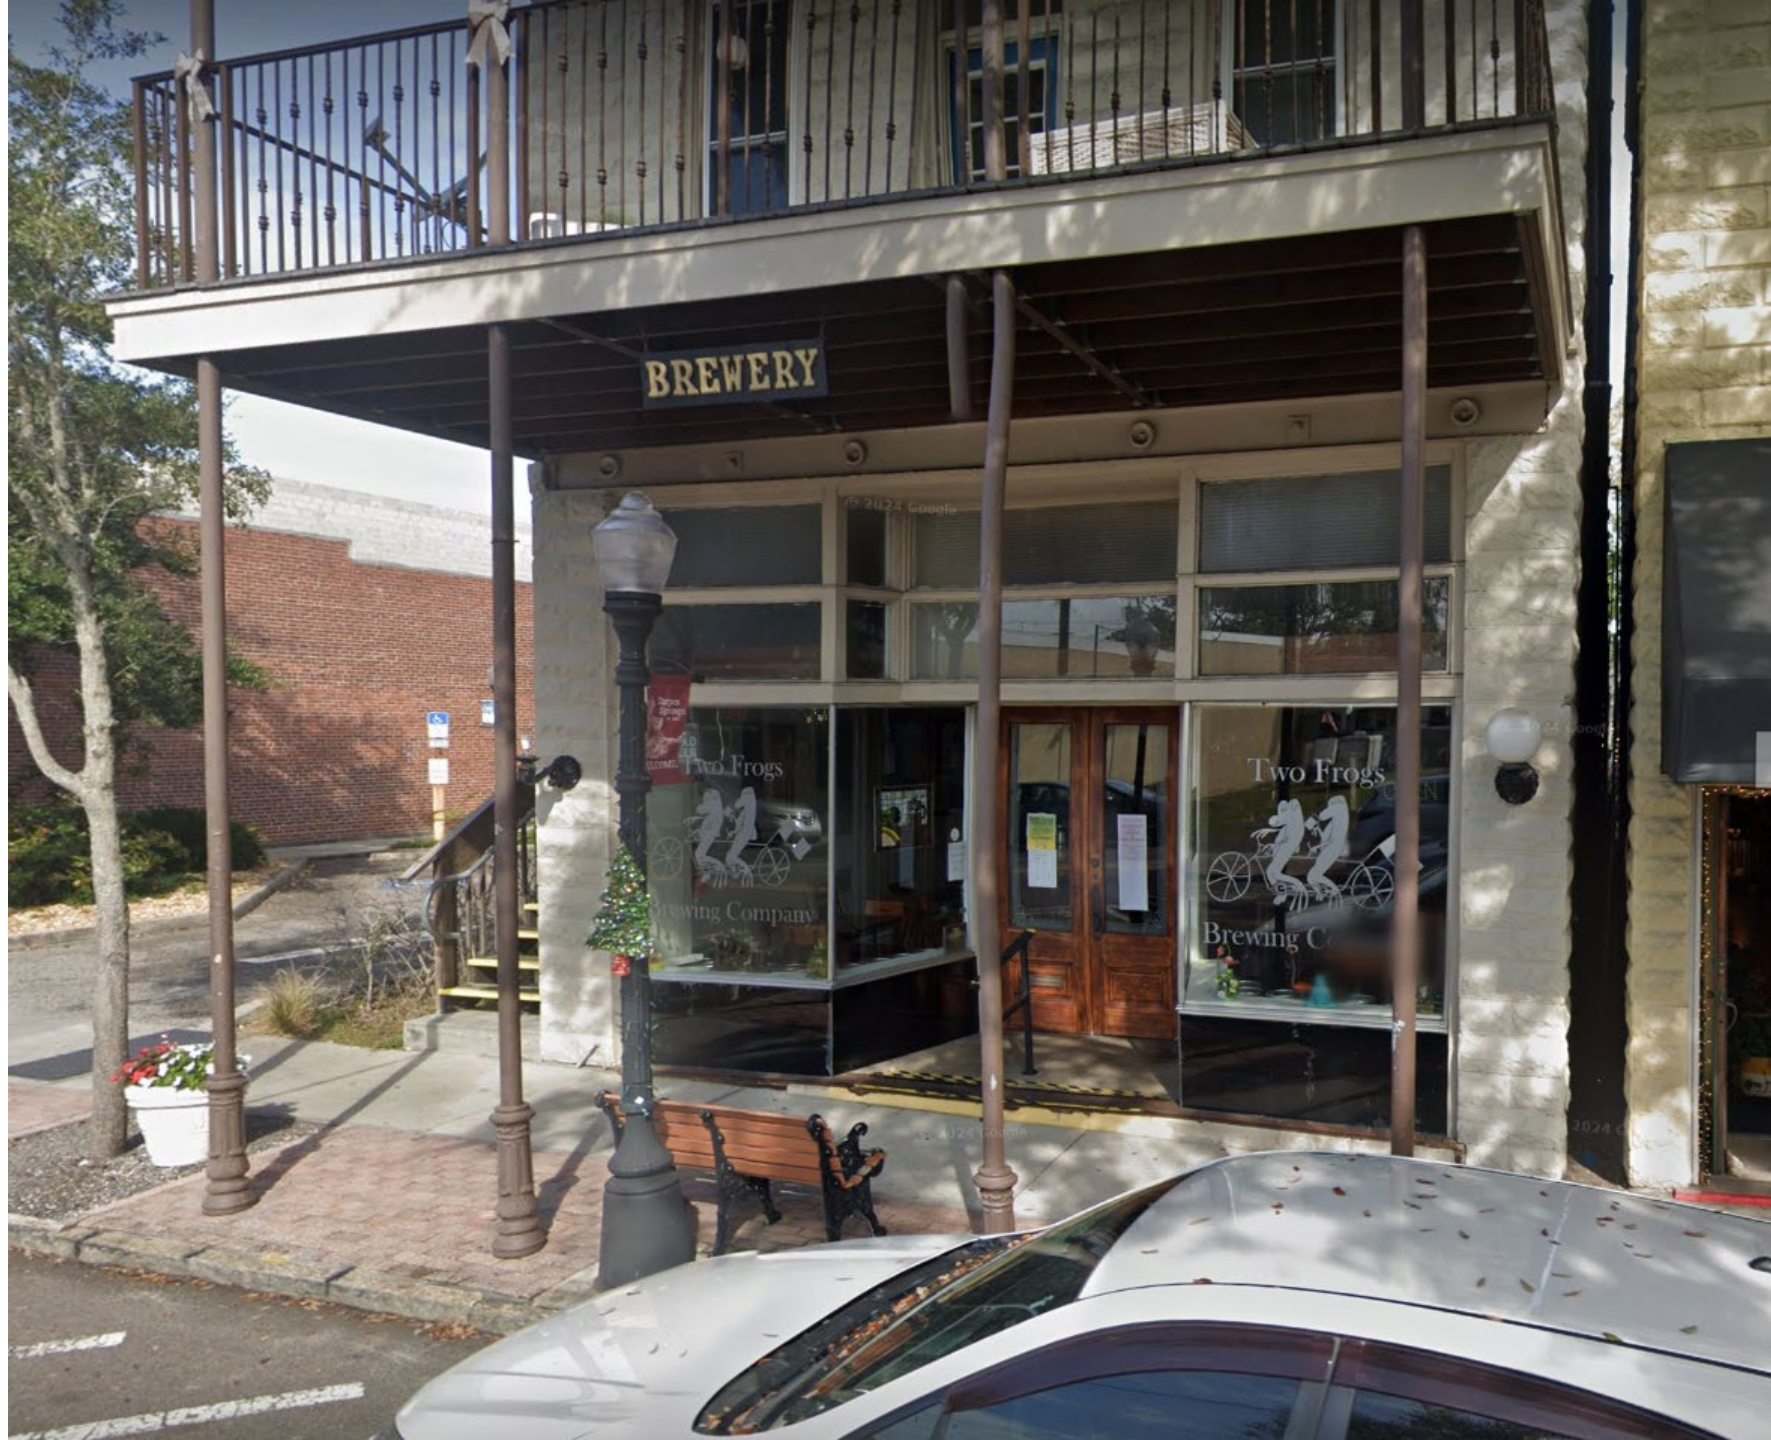
151 E Tarpon Avenue was rehabilitated in 2015 with a similar storefront cornice. Restoration was achieved through sealing and painting.

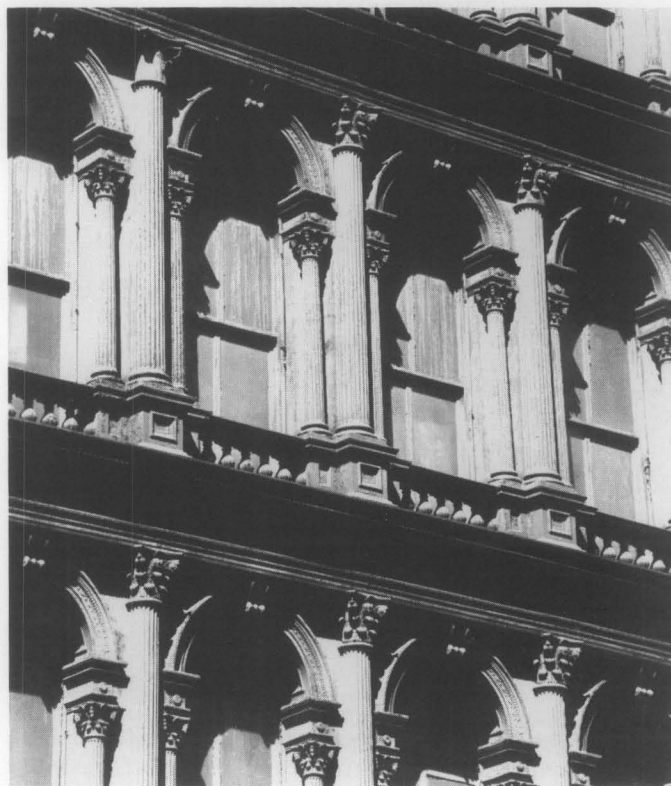
Fig. 1. The Haughwout Building in New York City is an excellent example of the quality and character of mass-produced cast-iron architecture. Once wood patterns were made, any number of elements could be cast, as was done with each of these repetitive bays. Photo: New York City Landmarks Preservation Commission.

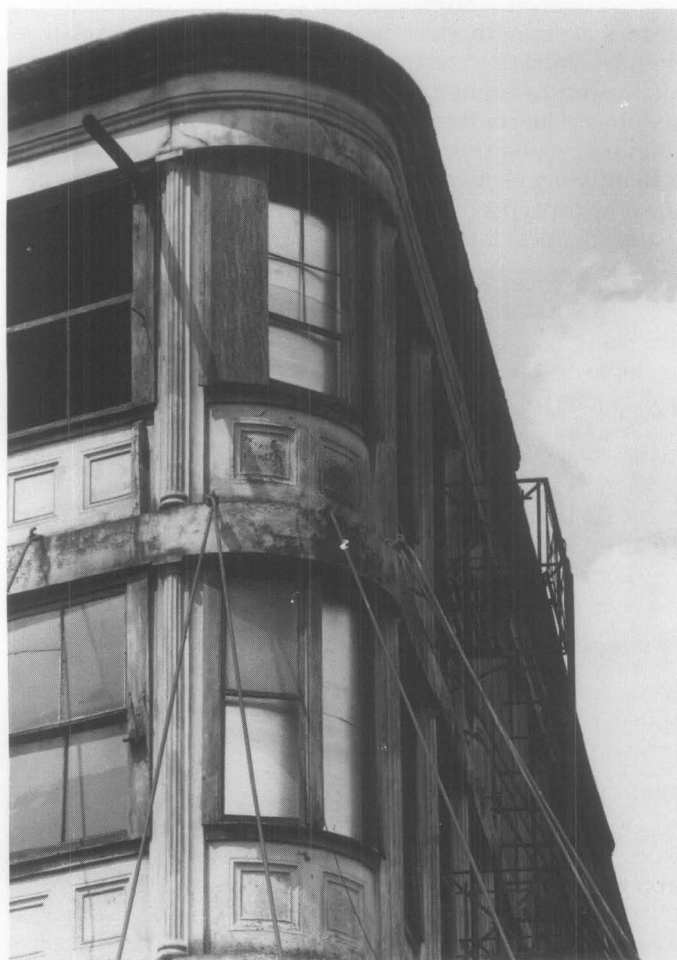
Fig. 2. The Edgar Laing Stores Block in New York City was designed by James Bogardus. It was the first building constructed with facades of self-supporting cast iron. This corner view shows the Doric-style engaged columns, panels, and spandrel beams; the loss of most of the original ornamental castings give it an austere look. As part of an urban renewal project, the facades were carefully disassembled in 1971 for later re-erection in another location—only to have its iron parts stolen for scrap. Photo: Jack E. Boucher, HABS Collection.

In 1849 Bogardus created something uniquely American when he erected the first structure with self-supporting, multi-storied exterior walls of iron. Known as the Edgar Laing Stores, this corner row of small four-story warehouses that looked like one building was constructed in lower Manhattan in only two months. Its rear, side, and interior bearing walls were of brick; the floor framing consisted of timber joists and girders. One of the cast-iron walls was load-bearing, supporting the wood floor joists. The innovation was its two street facades of self-supporting cast iron, consisting of multiples of only a few pieces—Doric-style engaged columns, panels, sills, and plates, along with some applied ornaments (cover photo and Fig. 2). Each component of the facades had been cast individually in a sand mold in a foundry, machined smooth, tested for fit, and finally trundled on horse-drawn drays to the building site. There they were hoisted into position, then bolted together and fastened to the conventional structure of timber and brick with iron spikes and straps (Fig. 3).

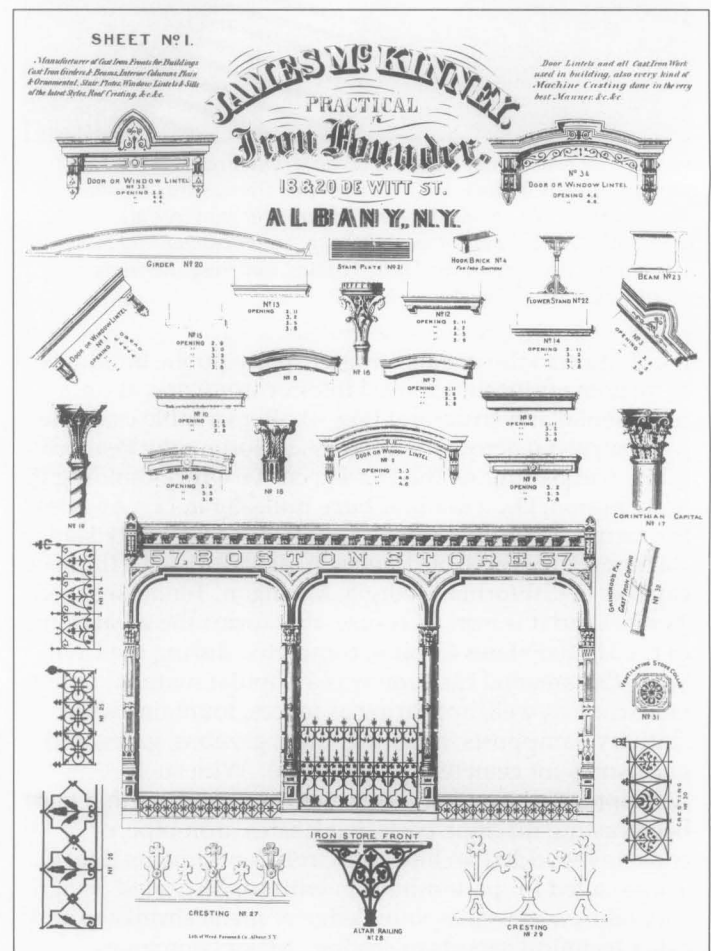
Fig. 6. Sheet from a late 19th century manufacturer's trade catalog illustrates some of the products available from foundries, such as storefronts, girders and beams, columns, stairs, window lintels and sills, and roof crestings. Courtesy: Albany Institute of History and Art.

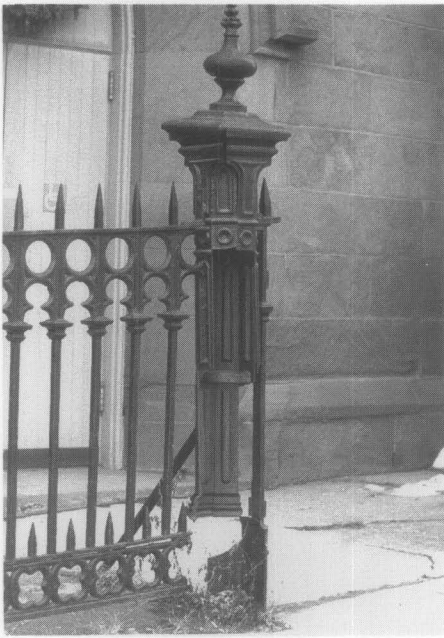
*Fig. 7. Despite an impact that shattered the main castings, this fence post remains upright, demonstrating the great strength of cast iron. Originally, the post was held together by a long bolt that extended from the finial to the base. Photo: John G. Waite.*

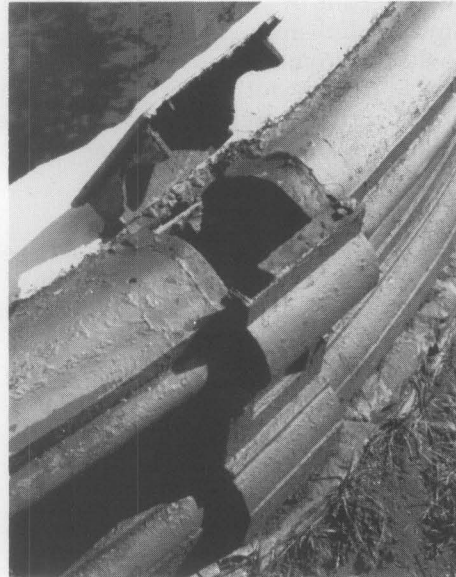
*Fig. 9. Galvanic corrosion occurred where a patch of copper was installed alongside the cast-iron cap at the base of a fountain. The use of terne-coated stainless flashings with appropriate caulking would have been a more suitable repair. Photo: John G. Waite.*

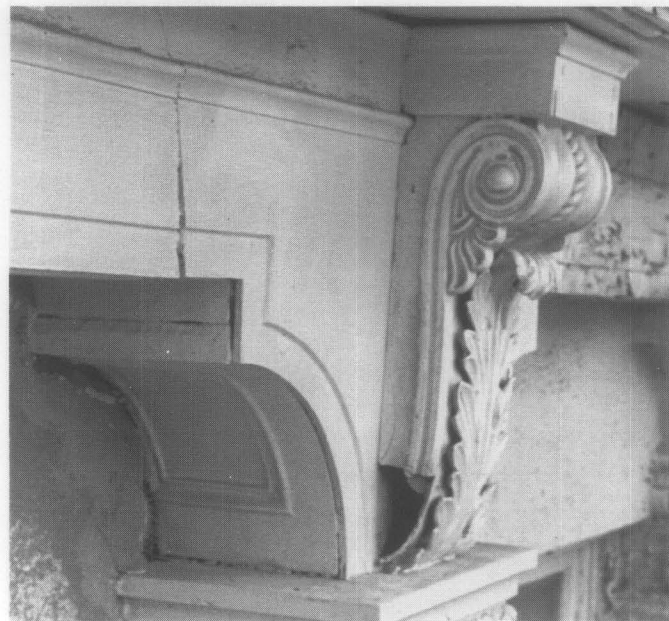
*Fig. 8. Structural cracks, gaps at joints between components, and a large opening where part of the console bracket is missing are the problems evident in this cast-iron assembly. Photo: Ford, Powell & Carson.*

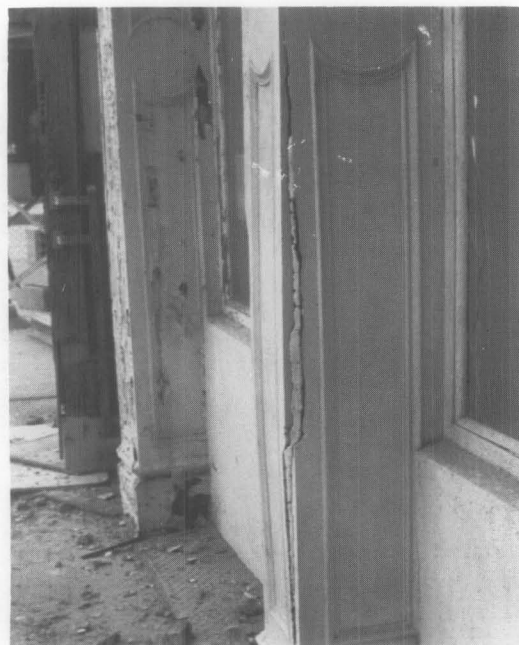
Fig. 11. Major cracks in the piers of this cast-iron storefront in Galveston, Texas resulted from the transfer of load onto the iron from internal brick piers eroded by rising damp. This crack was inappropriately filled with concrete, which trapped moisture and accelerated internal corrosion, pushing the iron further apart. Photo: Ford, Powell & Carson.

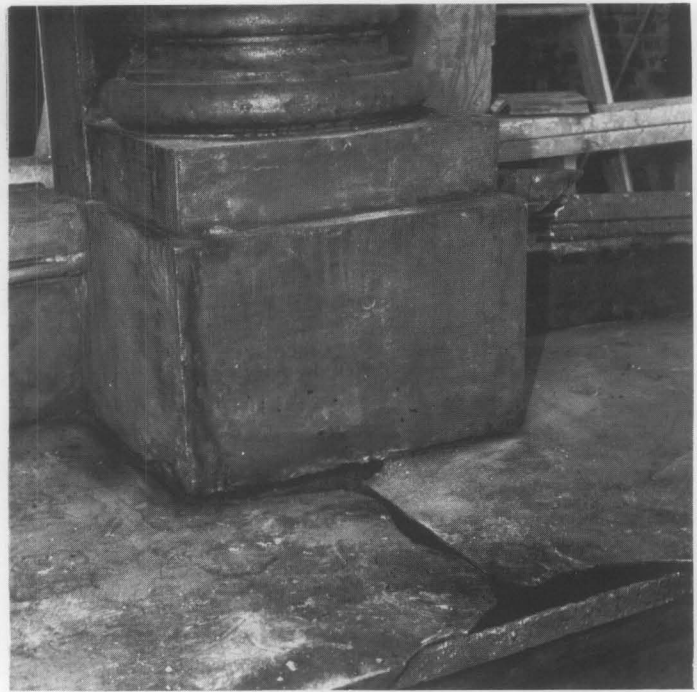
Fig. 12. Paint stripping exposed a large defect under a faulty patch at a joint of this wide cast-iron watertable. The damage can be repaired mechanically by splicing in a cast-iron replacement piece. Photo: Peter Jensen, Kapell and Kostow Architects.

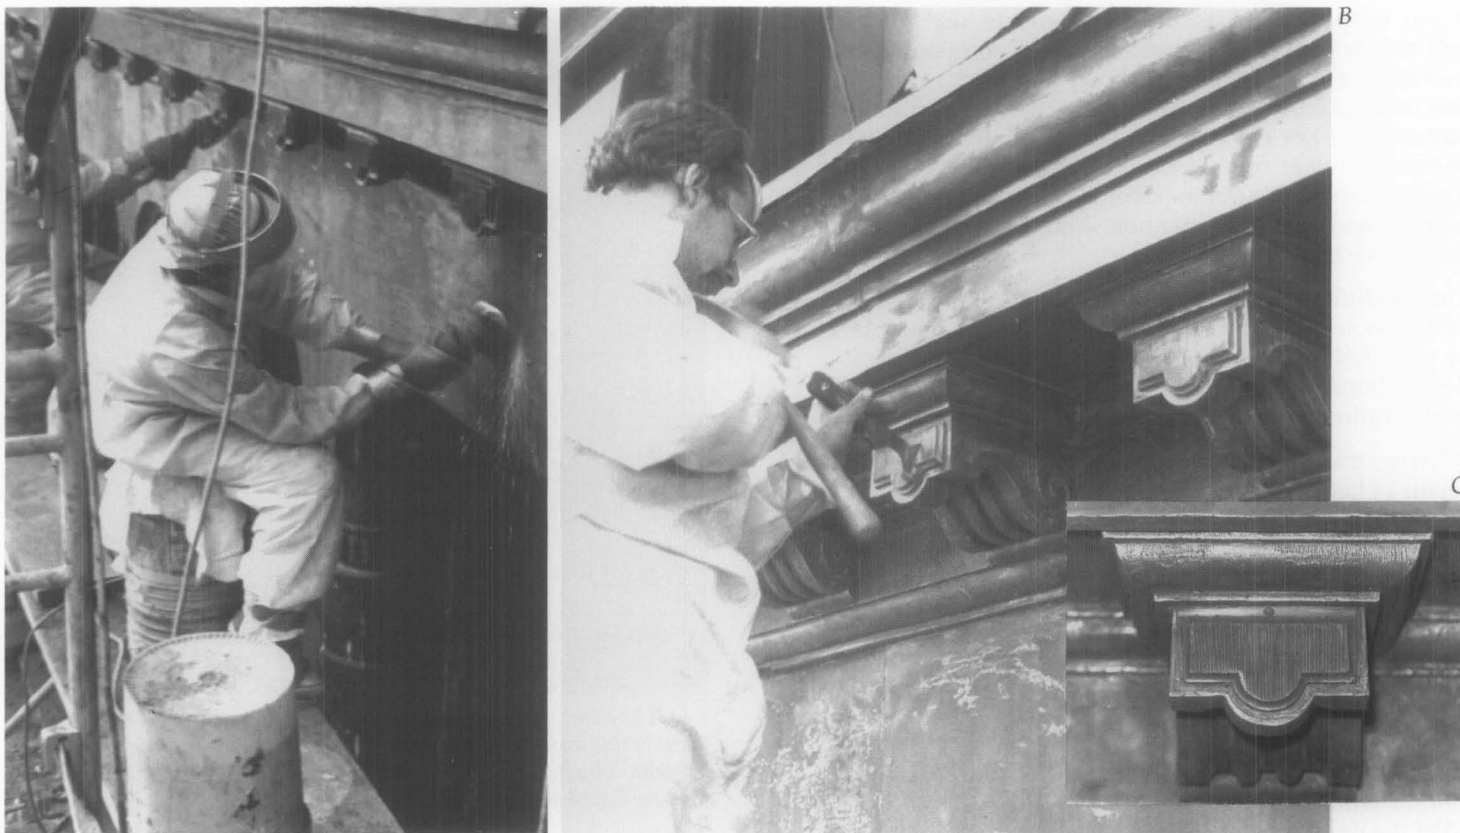
Fig. 13. Surface preparation may involve several different techniques. Where chemical paint stripping is involved, careful planning of the sequence of work and inspection by an architect or conservator to ensure strict compliance with the contract documents is important to minimize the risk of problems. After the chemical paste and paint was scraped off, the remaining paint and chemical residue were removed with a wire brush (a) and scrapers selected or cut to fit the shape of the iron surfaces (b). The surface was then wiped with solvent to create a completely clean surface prior to repainting (c). Photos: Raymond M. Pepi, Building Conservation Associates.

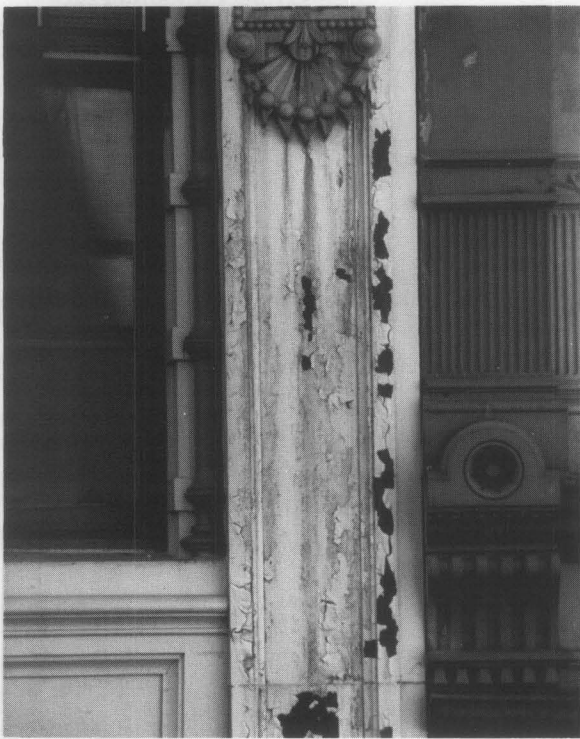
*Fig. 14. Major problems can result if work is undertaken without proper sequencing and precautions. On this building, a strong alkaline paint remover was used, and apparently was not adequately rinsed or neutralized. Over a period of months, the newly applied paint began to peel and streaks of rust appeared on the iron. Photo: Kim Lovejoy.*

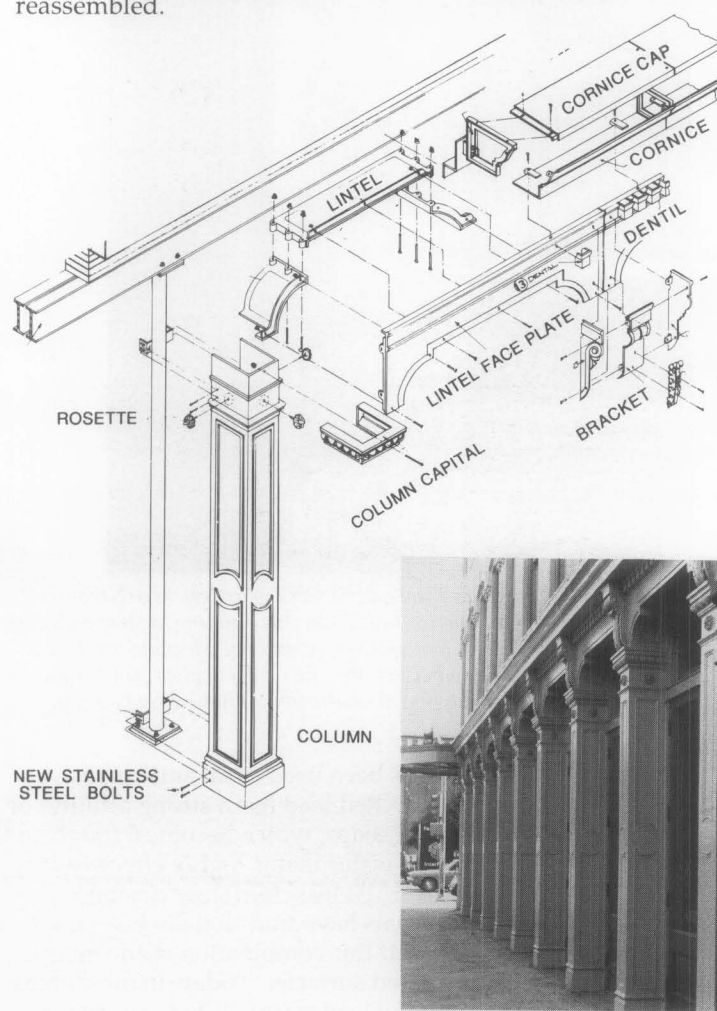
Fig. 16. Architectural cast iron is made of many small components bolted and screwed together. (a) This exploded view of a storefront illustrates the variety of elements, including brackets, fasteners, and holes for bolts. (b) The storefront was replicated in cast iron because of the extensive damage and structural failure, a detail of which is shown in Fig. 11. Drawing and photo: Historical Arts & Casting, Inc.

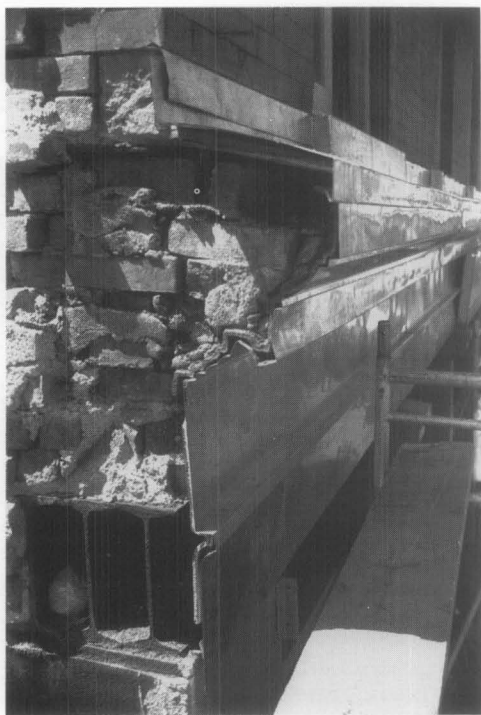
Fig. 18. This cast-iron storefront cornice was corroded beyond the point of repair, and could not be removed easily for replacement. Terne-coated stainless steel, the most durable metal for flashing cast iron, was applied to the cornice and fitted as closely as possible to the historic profile. Although painting is not necessary to protect terne-coated stainless steel, the cornice should be painted to be consistent with the historic character of the building. A primer which is compatible with the terne coating should be used. Photo: Dean Koga, Robert E. Meadows, P.C., Architects.

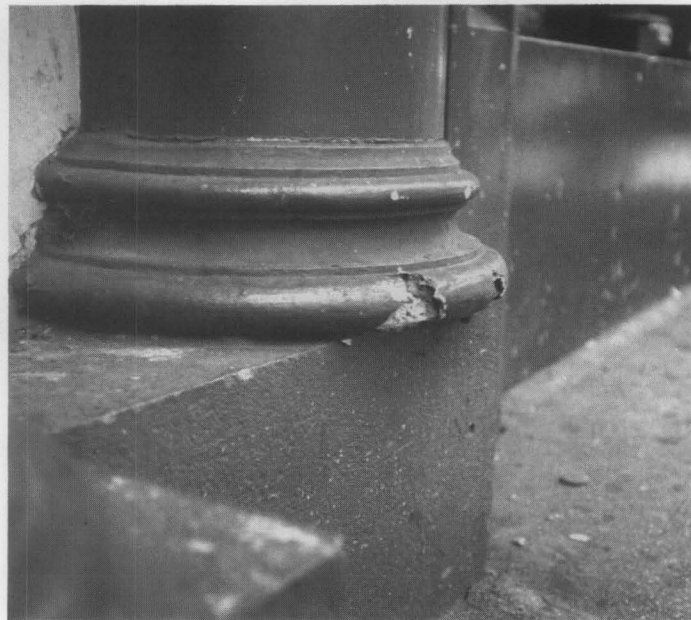
Fig. 20. The location of the feature must be taken into account if a substitute replacement material is being considered. This lightweight fiberglass column at street level sustained damage from impact within a few years of installation. The great strength of cast iron makes it ideal for storefronts and elements that must withstand heavy use. Photo: Building Conservation Associates.

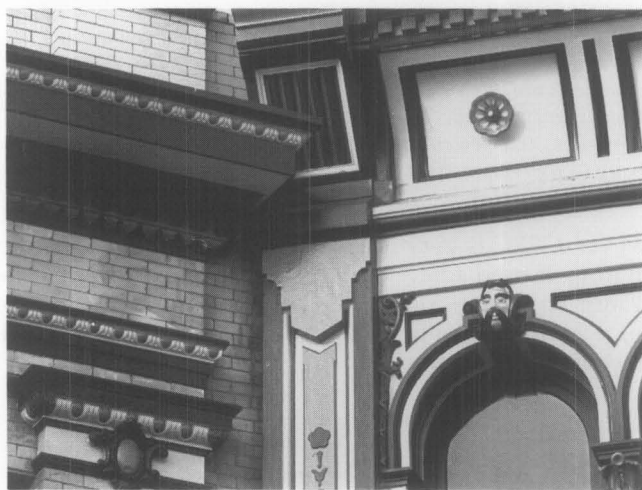
Detail of polychromed cast-iron facade at 23 Petaluma Boulevard, Petaluma, Calif. (1886; O'Connell and Lewis, *Architectural Iron Work*, San Francisco). Photo: Don Meacham.

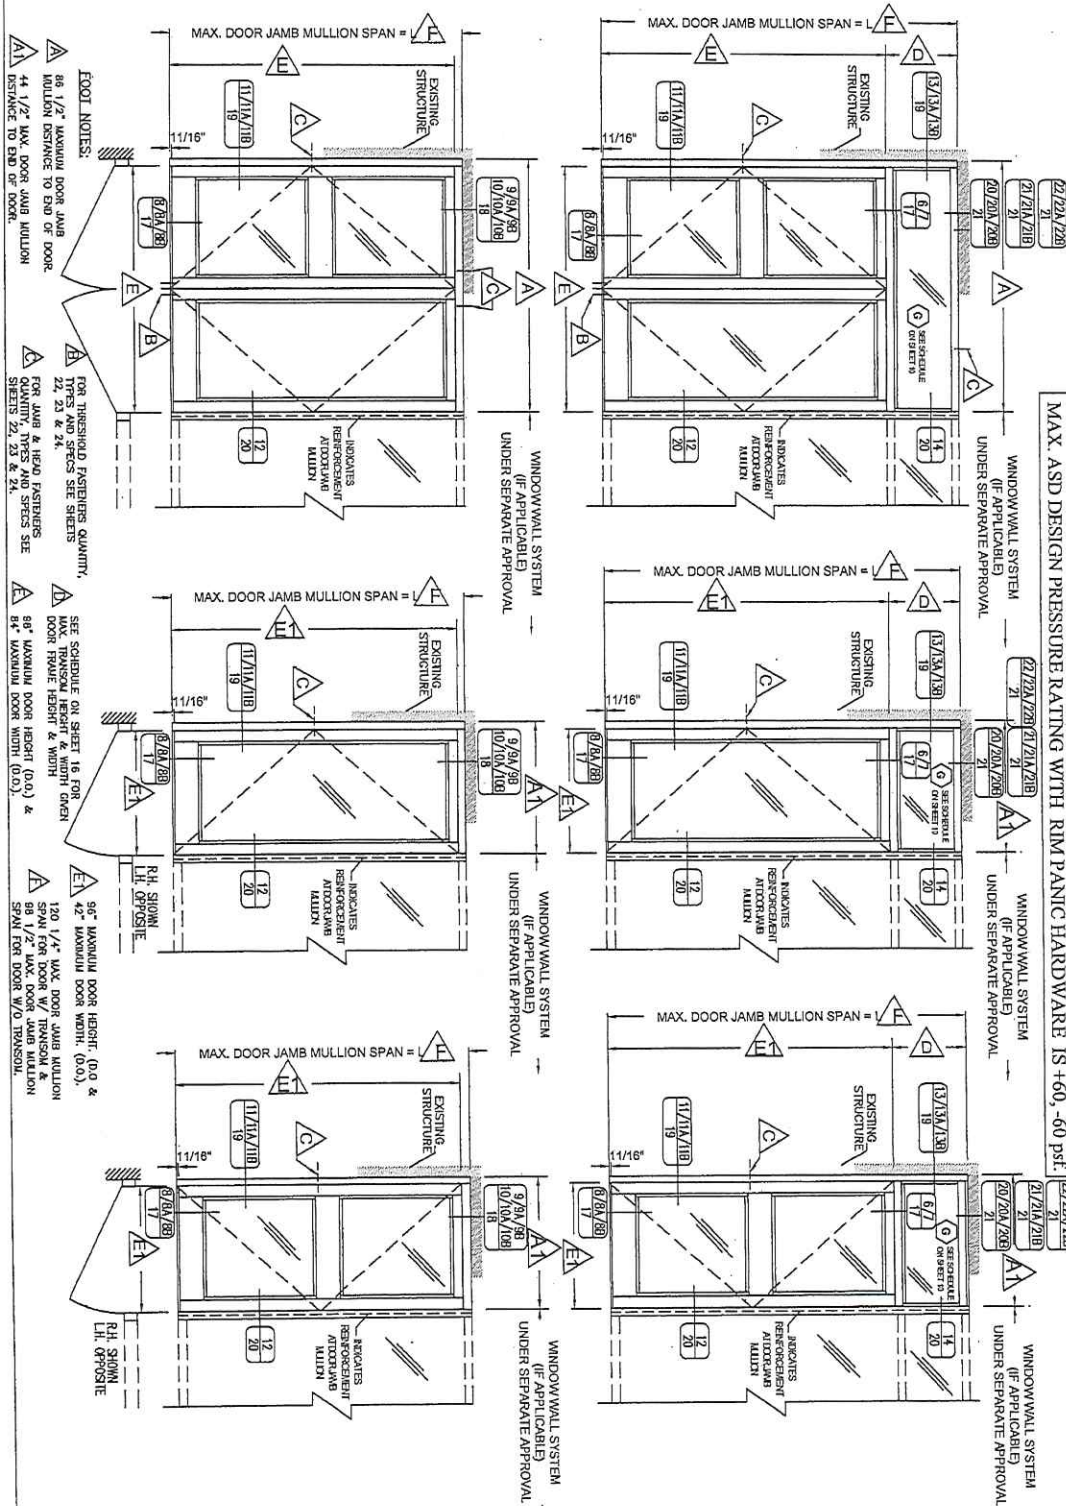
MAX. ASD DESIGN PRESSURE RATING WITH LAMINATED GLASS IS +70, -80 psf.  
 MAX. ASD DESIGN PRESSURE RATING WITH INSULATED GLASS IS +70, -70 psf.  
 MAX. ASD DESIGN PRESSURE RATING WITH RIM PANIC HARDWARE IS +60, -60 psf.
