# City of Tarpon Springs, Florida

- a. **Application 26-23:** Certificate of appropriateness to replace shingle roof with composite material.  
**Location:** 23 Parkin Court

**CITY OF TARPON SPRINGS**  
**HERITAGE PRESERVATION BOARD**

**APRIL 6, 2026**  
**STAFF REPORT**

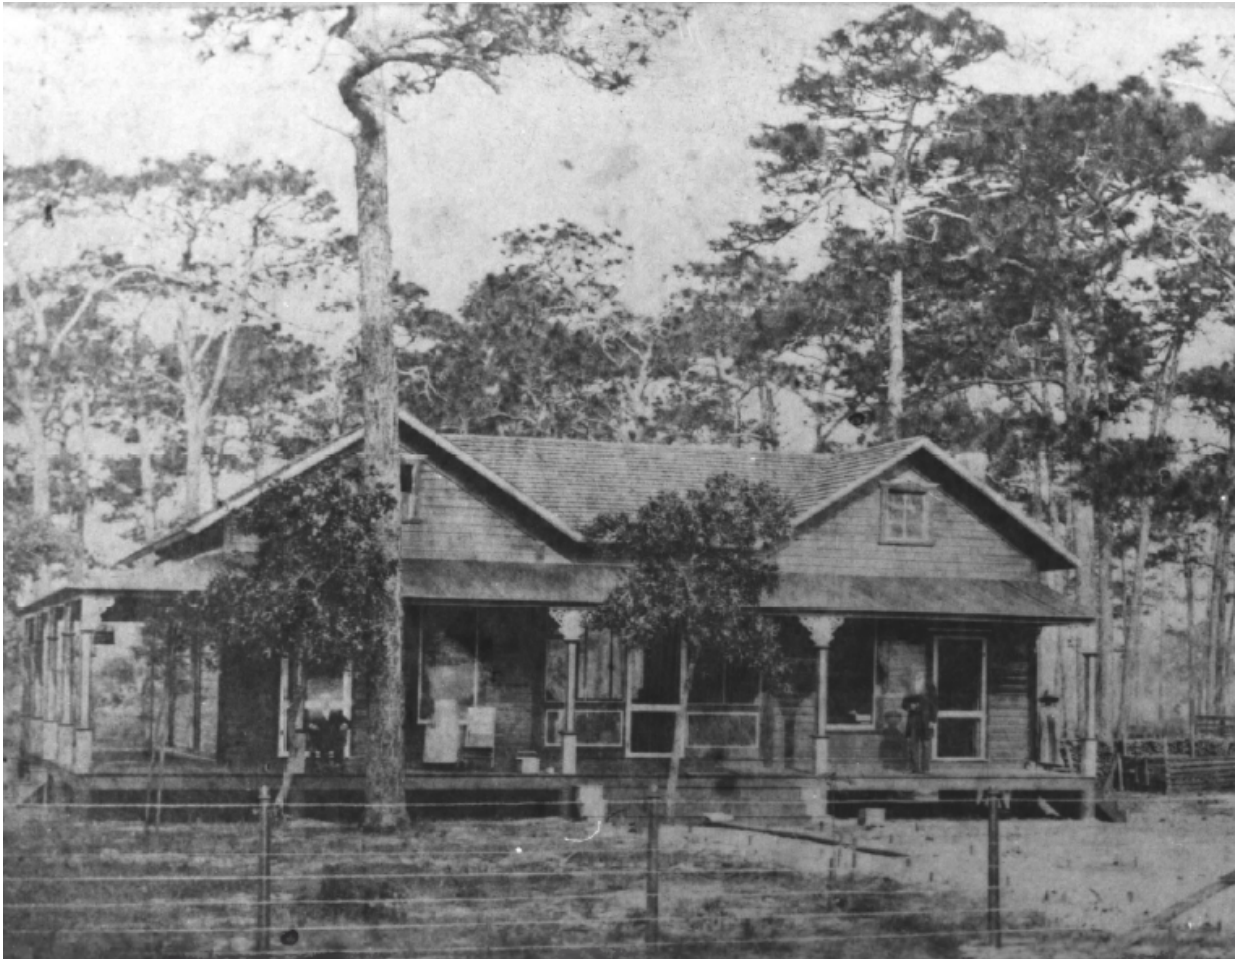
Figure 1. Safford House before 1887; note use of wood shingles on the primary roof (Safford House NRHP Nomination 1974).

- A pre-1887 photograph shows the Safford House prior to the construction of the second-story addition. Wood shingles are visible on the primary roof (**Figure 1**). The material cladding the porch roof is not clearly identifiable. It may have been metal; however, aluminum roofing was not widely used until the early twentieth century and the use of iron or copper for roofing were generally rare outside major metropolitan cities in the United States. The material may also have been wood board or canvas covered wood board.

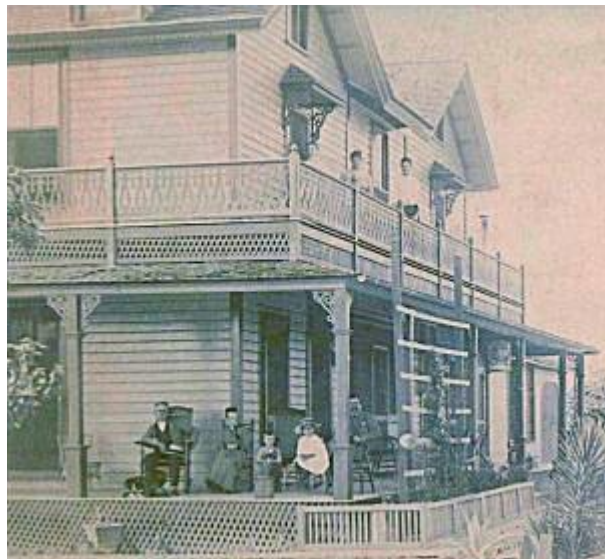
Figure 2. Safford House between 1887 and 1891 after the construction of the second-story addition (Tarpon Springs Historical Society).

- An undated photograph taken between 1887 and 1891 (after the second-story addition) shows the primary roof and first-story porch roof clad in wood shingles (**Figure 2**). The porch pictured in this photograph was replaced sometime after 1891 and is no longer extant.

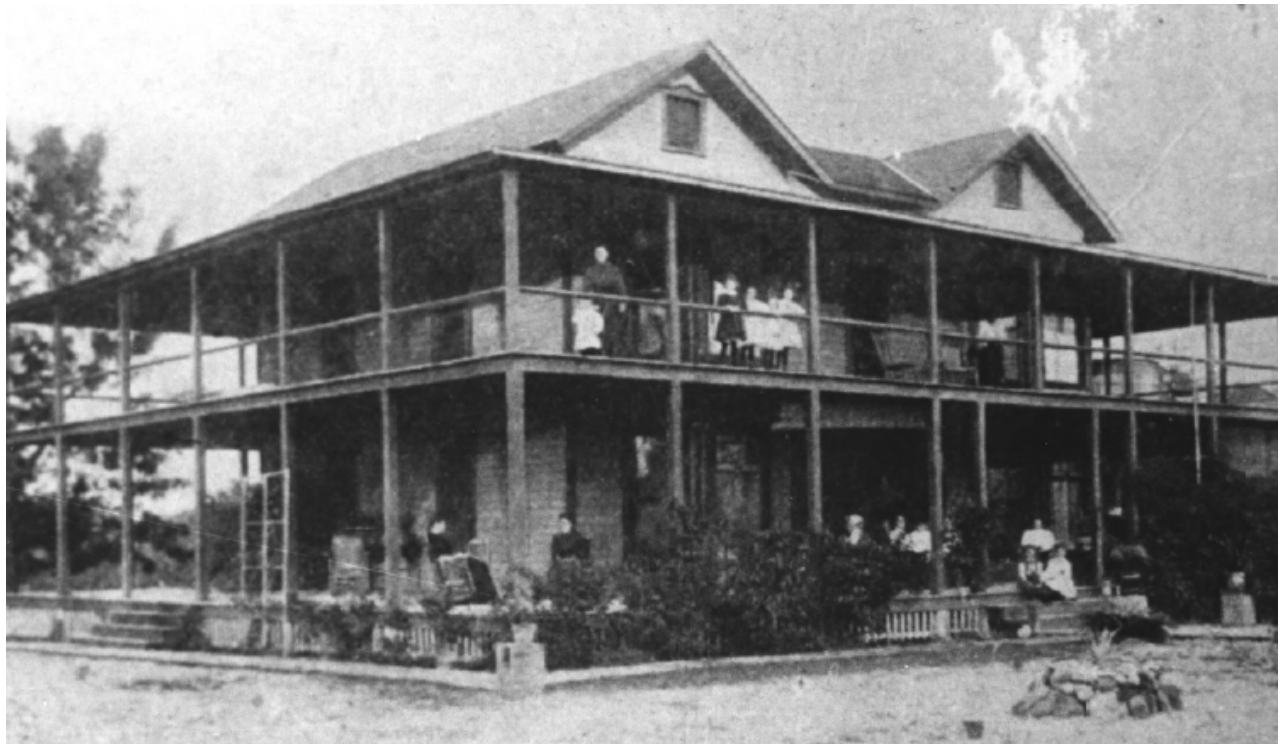
Figure 3. Safford House after 1891; roofing material type not definitively discernable (Safford House NRHP Nomination 1974).

- An undated photograph taken sometime after 1891 does not clearly show the primary or porch roof materials (**Figure 3**).
- A 1973 photograph shows the second-story porch roof clad in standing seam metal (**Figure 4**). The primary roof material is not visible.

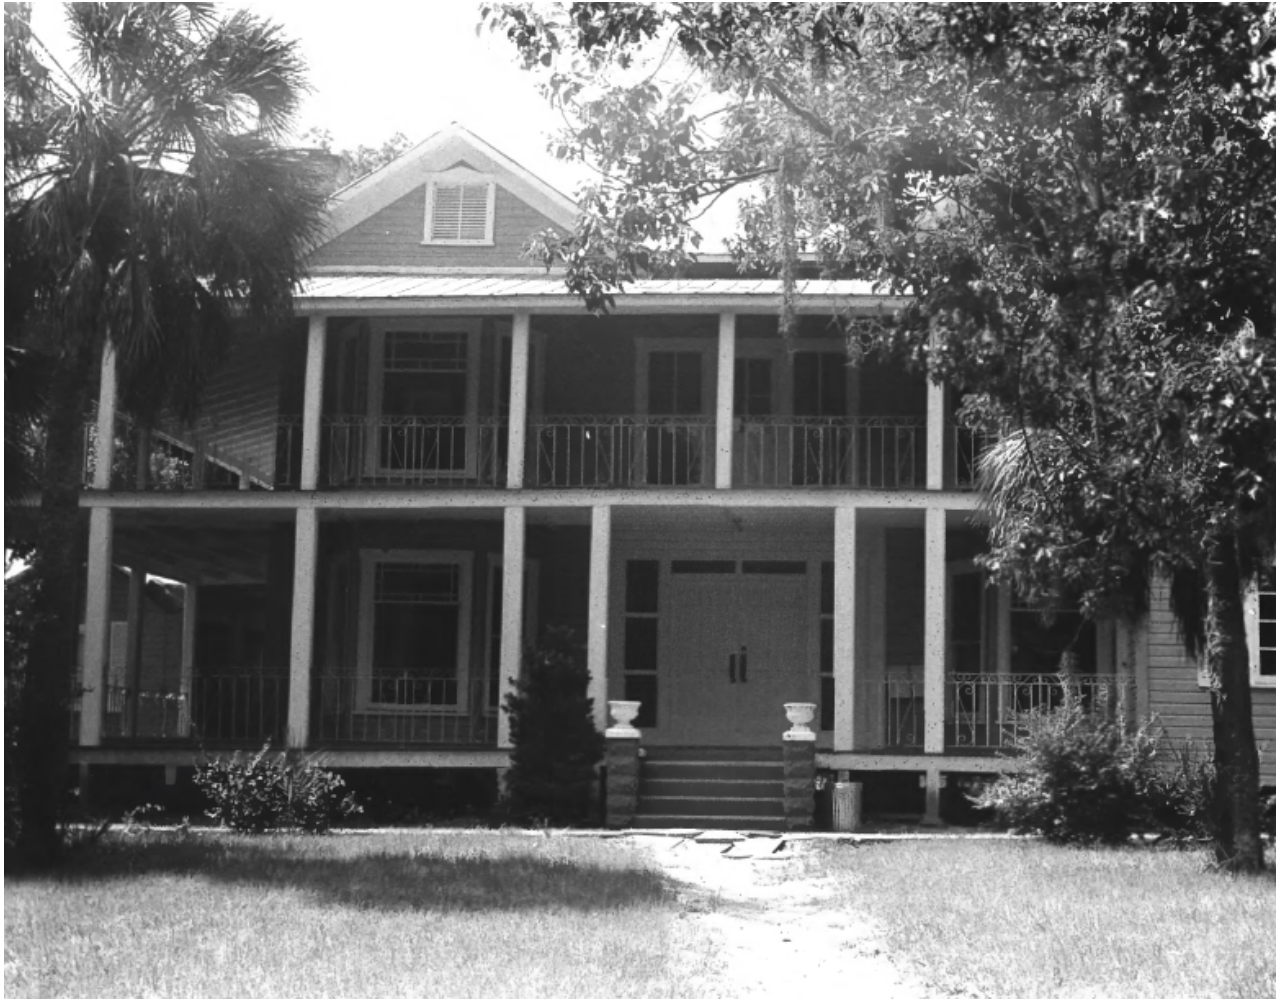
*Figure 4. Safford House in 1973; note standing seam metal roofing on second-story porch (Safford House NRHP Nomination 1974).*
